# **Laborer Electrocuted When Jackhammer Strikes Underground Power Line**

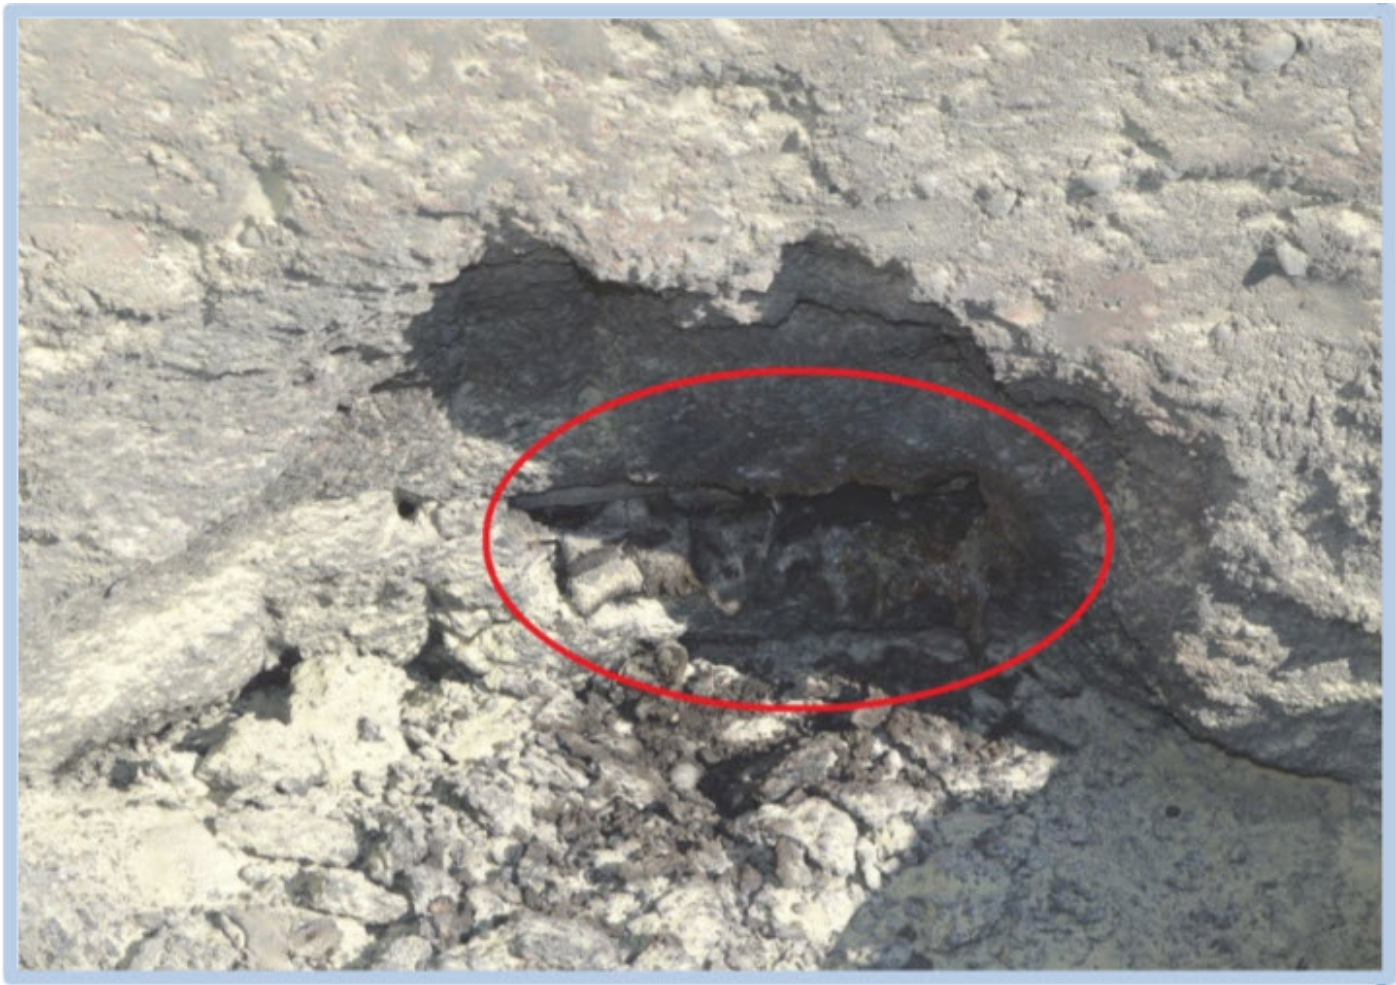
This duct bank contained three lines of PVC electrical conduit piping encased in concrete. Each line of conduit piping contained four power line cables carrying 7,200 volts each. In order to install the storm drain pipes to the necessary grade, the employees were using an excavator, breaker bar, and a rivet-buster-type jackhammer to chip away at the duct bank concrete.

The victim was in the trench chipping the duct bank's concrete when his rivet buster punctured the conduit and contacted the power line cable. He was electrocuted and died at the scene.

*Incident scene where the laborer struck the 7,200-volt power line with his jackhammer as he was chipping away at the concrete encasement of the duct bank.*

Inspectors had the following recommendations to prevent future similar incidents: Determine the exact locations of buried power lines before beginning work.

- Always assume that power lines are energized unless you have confirmation from the power line owner or utility company that the lines have been de-energized and grounded.
- Do not perform work that may expose employees to contact with energized power lines.
- General contractors and subcontractors should plan before the start of a project and coordinate during the project on a site safety plan that identifies and addresses hazards to employees.
