# Picture This: Defying the Laws of Physics and Common Sense:

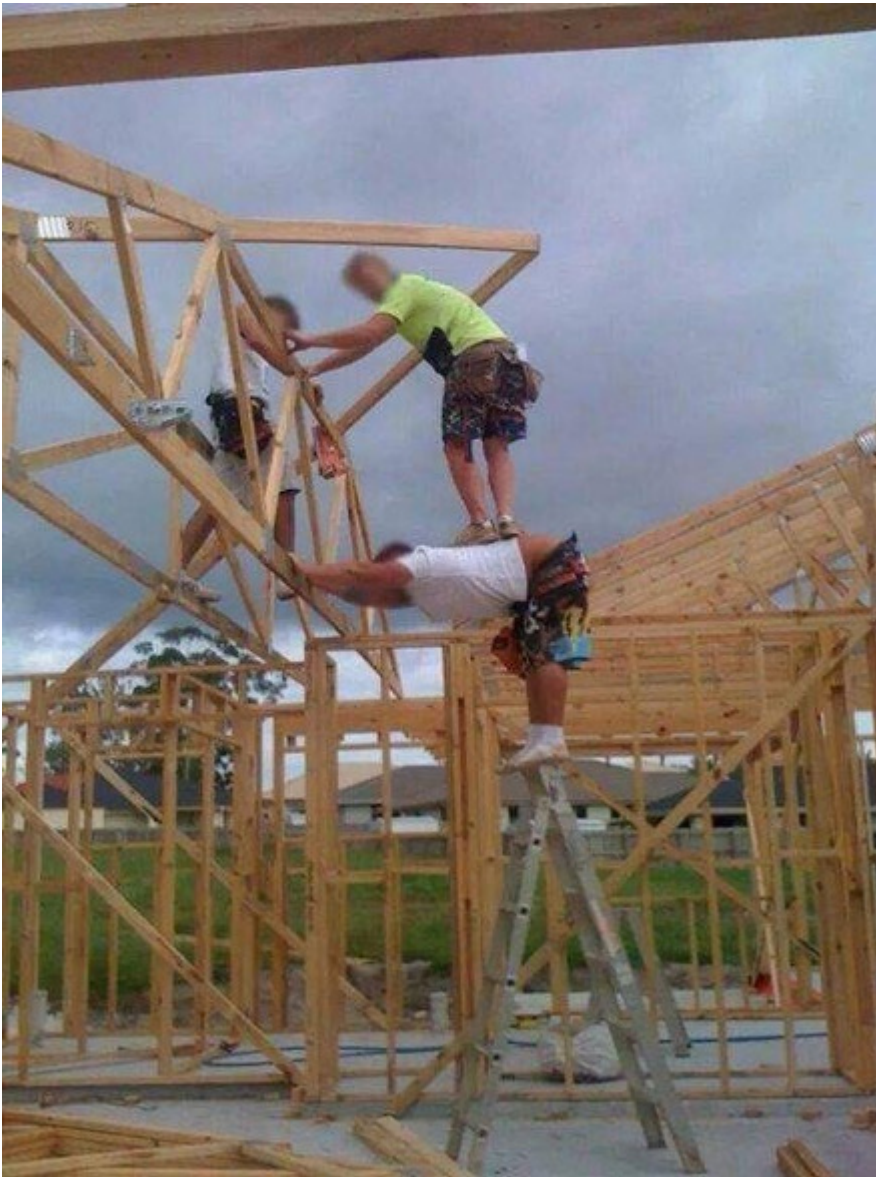
It's almost hard to know where to begin this one – but once the shock and awe wears off, it's obvious there's a lot wrong with this picture.

First, the workers in this picture aren't wearing any sort of PPE. No hard hats, safety, glasses, fall protection, or safety shoes, just to state the obvious.

Second, the obvious unsafe use of a ladder. Only one person should be on a ladder at a time. The area around the ladder's base is not cleared of trip and fall hazards. You should never stand on the top two rungs of a stepladder.

Third, while we don't know for sure, it does look a bit stormy in the background. Lightning and other weather-related hazards could very likely be present. If that's the case, these workers should seek shelter immediately or they all three could end up being a lightning rod!
