Upper Boom Failure on Aerial Lift

Incident Summary

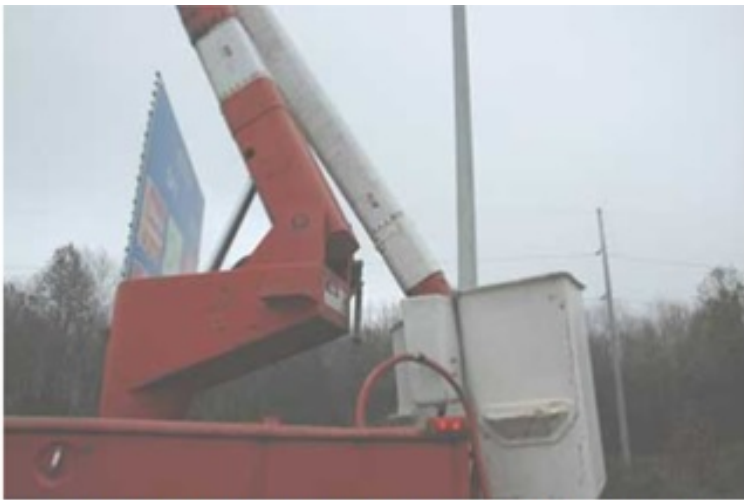
A 45-year-old owner of an electrical contracting company died after falling 9 feet to the road when the articulating boom of the aerial lift truck he was working from collapsed (photo 1).

Photo 1: Aerial lift boom after incident. Note that the lower boom section remains elevated while the bucket-end of upper section is in a lowered position (photo courtesy of OSHA).

The victim, working at a height of approximately 35 feet, was changing light bulbs on overhead streetlights along a state highway. After replacing a bulb, he began lowering the boom. The upper boom actuating chain connecting the upper and lower boom sections broke and the upper section fell, striking the truck bed. The impact broke the metal mounting bracket that attached the bucket to the boom tip causing the bucket to rotate away from the boom. The victim was thrown from the bucket, striking the back of his head and neck on the truck before coming to rest on the road surface. The six-foot lanyard did not prevent the victim from striking the truck as the distance from the lanyard's anchorage point to truck bed was less than six feet.

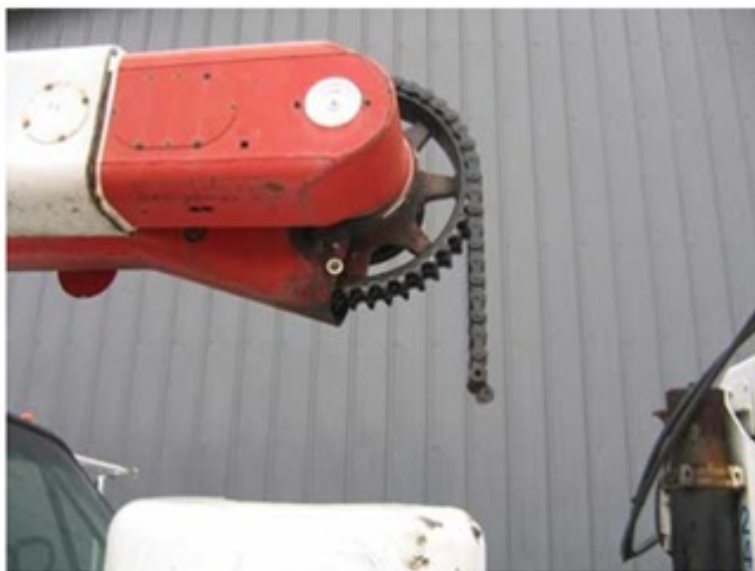
Post incident inspection of the articulating boom revealed the boom actuating chain had separated resulting in the catastrophic collapse of the upper boom (photo 2).

Photo 2: Broken boom actuating chain (photo courtesy of OSHA).

It appears lack of proper lubrication of the chain is likely what caused the chain to break. This incident highlights the significance of:

1. Reading and adhering to the manufacturers’ recommended maintenance schedule. The operation and maintenance manual detailed maintenance recommendations, procedures and warnings.

- In particular, the manufacturer recommended the roller chains, including the upper boom actuating chain, be lubricated every 30 days.
- A warning in the manual stated a lack of lubrication can cause galling and corrosion of the chain pins; breakage of

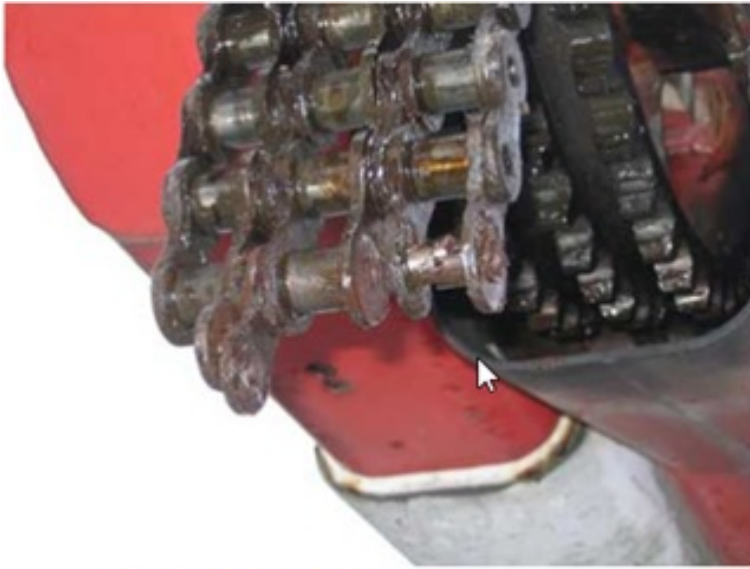
the pins; and result in free fall of the upper boom (photo 4).

Photo 4: Broken section of boom actuating chain
(photo courtesy of OSHA).

2. Pre-use inspection and removing suspect equipment from service until has been made safe to use.
3. Regular maintenance and inspection by a qualified person.
 - The operation and maintenance manual recommended regular maintenance and inspections to include – the upper boom actuating chain for lack of lubrication, broken rollers and pins.
 - It also stated lack of lubrication is indicated by squeaking or groaning noises when the booms are moved.
 - The recommended inspection/maintenance frequency for pulleys, sprockets, pins and chains is monthly. A major overhaul of the unit was recommended, according to average use, after 3 years or 6,000 hours of use, whichever came first
 - The aerial lift involved in this incident was 18 years old.
 - There was no record of maintenance and inspection having been performed on the boom structure or other assemblies of the aerial lift.
