Lathes Picture This

What´s wrong in this picture?

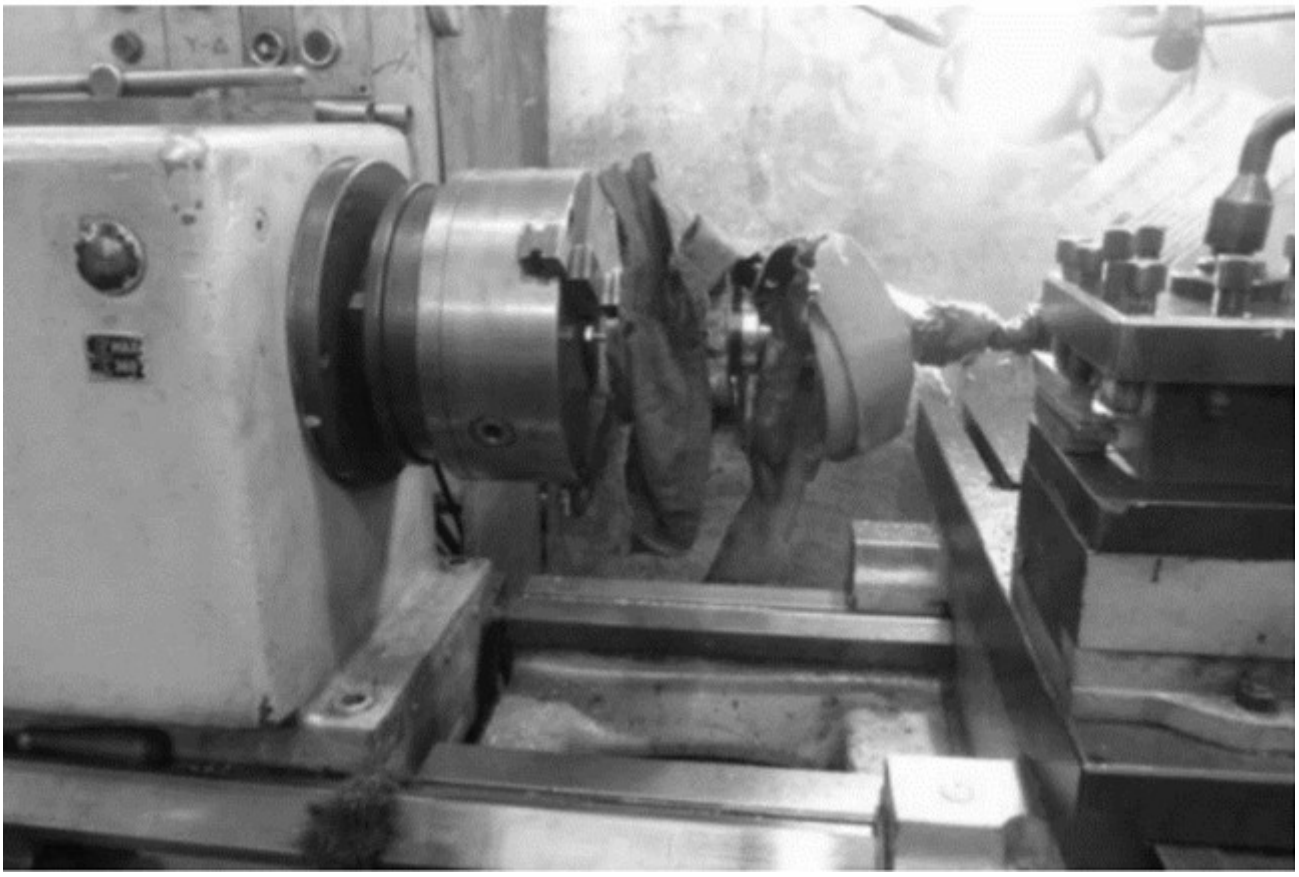
Rotating chuck showing overall sleeve and emery cloth entangled on the spindle. The chuck guard had never been fitted on the lathe. Although no engine ratings witnessed the accident, it was probable that either the emery cloth and / or the loose sleeve of the mechanic´s overalls were caught in the rotating chuck. The mechanic was then pulled over and held down over the rotating chuck, outside the reach of the emergency stop button.

In addition, the lack of a physical barrier around the chuck, the lathe had another design problem with the position of the emergency button, which was not within reach of the trapped and injured operator.

Lathes contain several fast-rotating parts that can cause contact and entanglement hazards. Keep all body parts away from all rotating parts. Never wear loose-fitting clothing or jewelry while operating a lathe.

So it is important to keep your hands and fingers away from any moving parts or cutting tools. Avoid reaching across the rotating chuck or work piece when you are filing or burnishing. Never use your hand to stop a moving chuck. Instead, move the cutting tool away from the metal, turn off the lathe and remove the work piece.
