Upper Boom Failure on Aerial Lift

Incident Summary

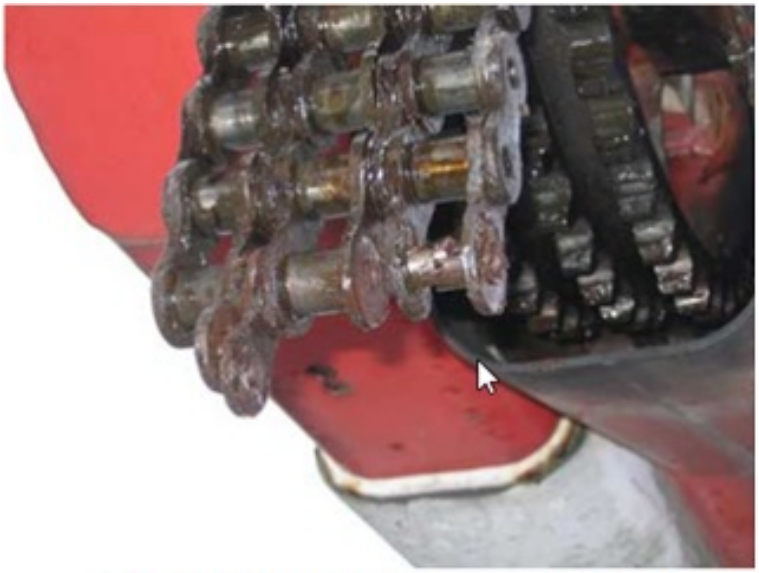
It appears lack of proper lubrication of the chain is likely what caused the chain to break. This incident highlights the significance of:

- In particular, the manufacturer recommended the roller chains, including the upper boom actuating chain, be lubricated every 30 days.
- A warning in the manual stated a lack of lubrication can cause galling and corrosion of the chain pins; breakage of

the pins; and result in free fall of the upper boom (photo 4).

Photo 4: Broken section of boom actuating chain (photo courtesy of OSHA).

1. Reading and adhering to the manufacturers’ recommended maintenance schedule. The operation and maintenance manual detailed maintenance recommendations, procedures and warnings.

2. Pre-use inspection and removing suspect equipment from service until has been made safe to use.

3. Regular maintenance and inspection by a qualified person.

- The operation and maintenance manual recommended regular maintenance and inspections to include – the upper boom actuating chain for lack of lubrication, broken rollers and pins.
- It also stated lack of lubrication is indicated by squeaking or groaning noises when the booms are moved.
- The recommended inspection/maintenance frequency for pulleys, sprockets, pins and chains is monthly. A major overhaul of the unit was recommended, according to average use, after 3 years or 6,000 hours of use, whichever came first
    - The aerial lift involved in this incident was 18 years old.
    - There was no record of maintenance and inspection having been performed on the boom structure or other assemblies of the aerial lift.
