# Stairway Collapse

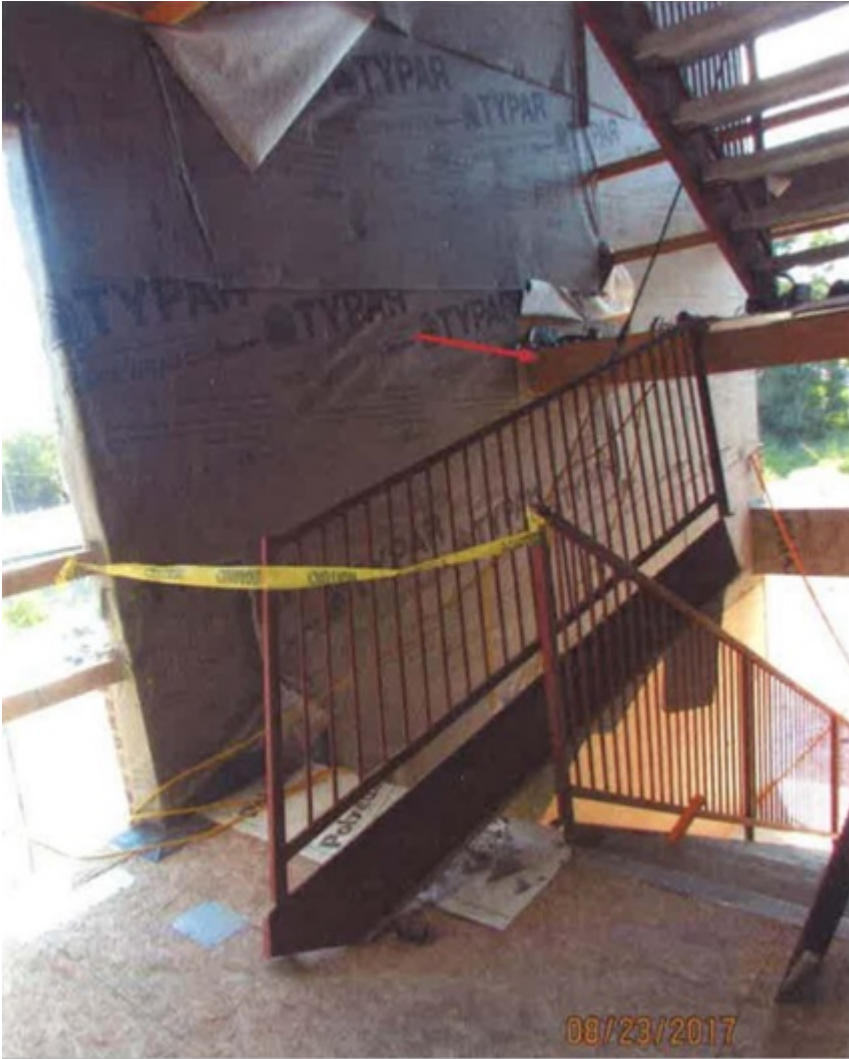
A 64-year-old male employee was fatally injured when the stairway he was standing on collapsed 17 feet (5 meters) to the concrete floor below.

On the day of the incident, the victim was installing a metal kick plate at the top of a steel bolt-in concrete tread stairway. To install the plate, the victim first removed the lag screws from the stairway landing.

These screws secured the top of the stairway frame, or stringers, to the landing. With the assumption that the stringers were secured at the bottom step, the victim began to remove the lag screws. The stairwell was **NOT** secured at the bottom and once he removed the lag screws at the top the stairs shifted and collapsed, and the victim fell 17 feet to the concrete floor below.

During the inspection and investigation of the incident it was determined that the employer did not inspect or evaluate the stairways before work began to determine if they were safe to use and could support the weight of workers.

The employer was cited for failing to have and maintain programs that provided for frequent and regular inspections of the job site, materials, and equipment. Regular inspections could have identified hazards, such as incomplete stairways that were being used by employees.
